## Case Study: Reliability Analysis of a Soil Slope

This article presents a case study where the PROKON Generalised Slope Analysis module (SlopBG) was used to evaluate the reliability of a partially failed soil slope.

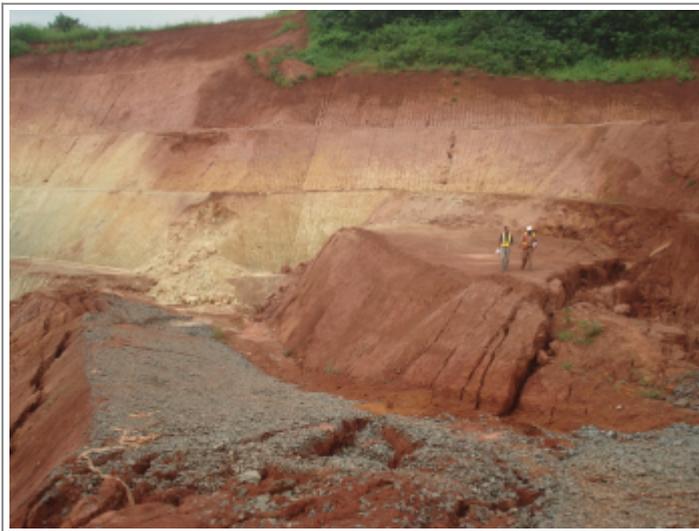
The slope, located in Uganda, comprises saprolitic soils, and consists of a series of 5m high, 4m wide berms, sloped at 1(V):1(H). Sections of the slope failed after heavy rains, raising concern about the stability of the remaining portions.

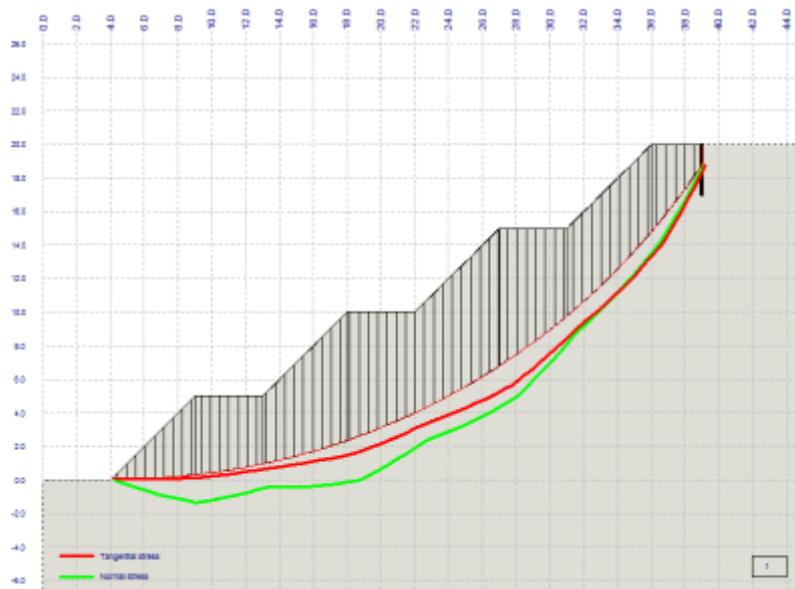
The author modelled the five-berm configuration in SlopBG. The software determined the slip circle that produced the minimum factor of safety (FOS), and predicted a value of FOS = 1.09. The FOS was not much higher than 1.0 (slope failure) suggesting that variations in the material properties could lead to localised slope failures.

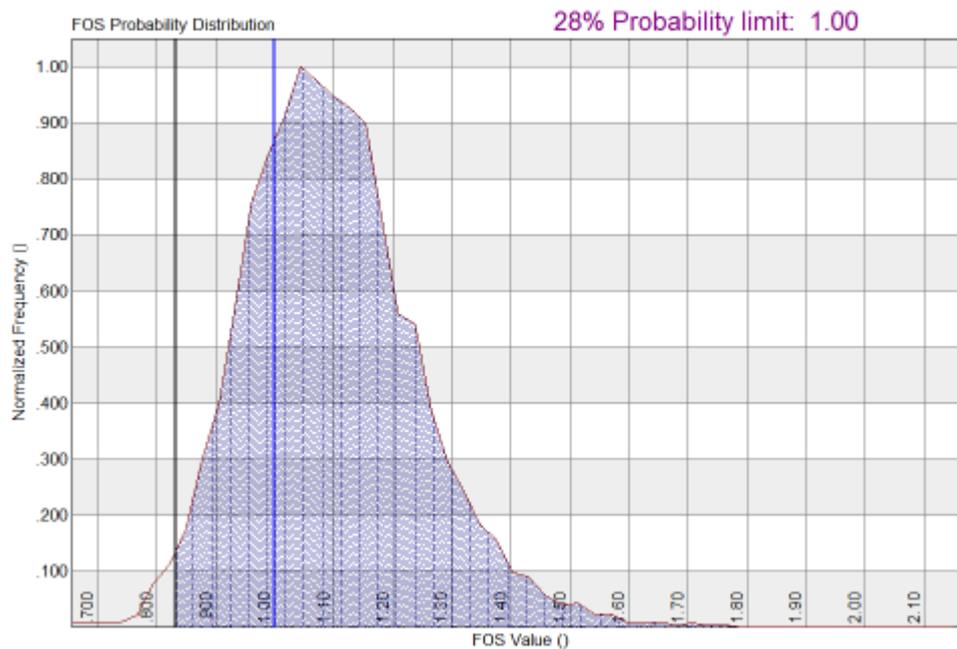
The analysis results indicated that the probability that the FOS would be less than 1.0 was 28%. On-site examination of the slope confirmed that this calculated figure was approximately correct.

Given that this reconstructed slope failed after heavy rains in a manner very similar to that as predicted in the computer analysis, it was surmised that the derived shear strength

and moisture parameters were very close to those that existed at the time of the failure.
